Bulletin No: SA20250422
Release Date: April 22, 2025
Effective Date: Immediate
Supersedes: N/A
Completion Date: 30 Days From Issue
Page: 1 of 7

SAFETY ALERT

Manufacturer: A.R.M. (USA), Inc. Model(s): VG100, VG200, VG300, VG400, VGPK100
Ride Name: Vertigo Affected Production Dates: ALL

Lift Winch Caliper Brake - Risk of Brake Failure

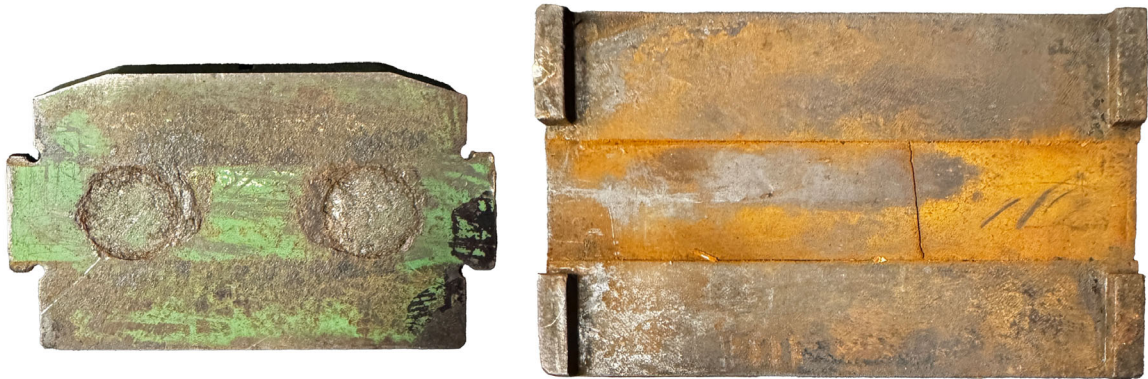
Corrosion has been discovered on a friction lining steel backing plate, causing a loss of retention of the Brake Friction Lining by the retention magnet. This condition creates risk of the Friction Lining coming detached from the shoe, and a complete loss of Caliper Brake Function. Weekly inspection and maintenance are required, as stated in the Ride Manual. Faulty conditions can lead to Failed Caliper Brake Performance. The entire Winch Caliper Brake system must be thoroughly inspected and any necessary maintenance or repairs completed *before* resuming operation. A weekly inspection is mandatory after compliance of this safety alert is met. Conditions such as corrosion, failed friction lining retention magnet, lack of lubrication, mis-adjustment, worn friction linings, contaminated friction lining surfaces, contaminated brake disc surfaces, hydraulic fluid leaks from the brake thruster, hydraulic fluid leaks from the thrusters' hose, hydraulic valve, or connections, as well as over tightened caliper mounting bolts are priority concerns. Reduced or failed operation of the hydraulically operated, spring applied caliper brake can lead to personal injury or death.

An immediate and overall inspection of the Winch Caliper Brake and its operational function must be performed. Specific instructions for inspection and testing are provided on the following pages.

1. Perform an overall inspection of the Winch Caliper Brake for signs of corrosion, wear and physical damage. Photograph and document all findings.
2. Remove the friction linings. Inspect the friction linings for corrosion, contamination, wear and physical damage. Corrosion, Dirt, Debris and Grease are contamination examples and are priority concerns. Any contamination must be remedied by cleaning and or parts replacement.

Note: Any Corrosion of the Friction Linings Steel Back Plate compromises retention to the shoe component.
If corrosion is found, replacement of the friction lining is mandatory. Re-lining of the Friction Linings is prohibited, this part must be replaced with an OEM product.

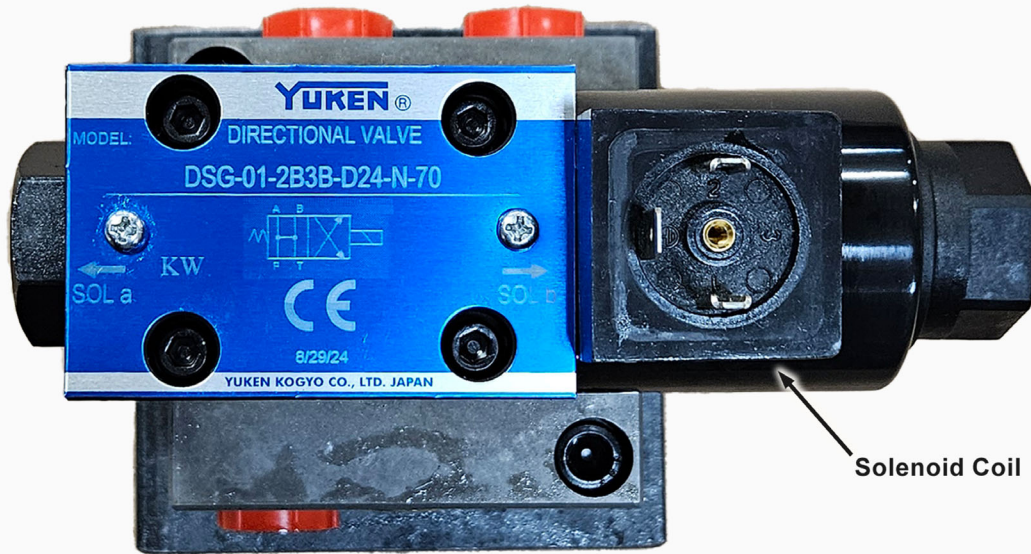
**FIGURE 4: HYDRAULIC VALVE COMPONENT IDENTIFICATION
TOP VIEW**

Solenoid Coil

Reference Figures 4 & 5 on Page 6 of this document for Hydraulic Valve Component Identification

6. While maintenance personnel 1 is pressing and holding the Hydraulic Brake Valves Manual Actuator, maintenance personnel 2 is to inspect and confirm the following. Note: Cycling the Manual Actuator multiple times during testing may be necessary.
 - a. Confirm a minimum hydraulic pressure of 50 bar (725 psi) is being applied to the Brake Thruster.
 - b. Inspect the hydraulic thruster and complete hydraulic circuit for signs of fluid leaks.

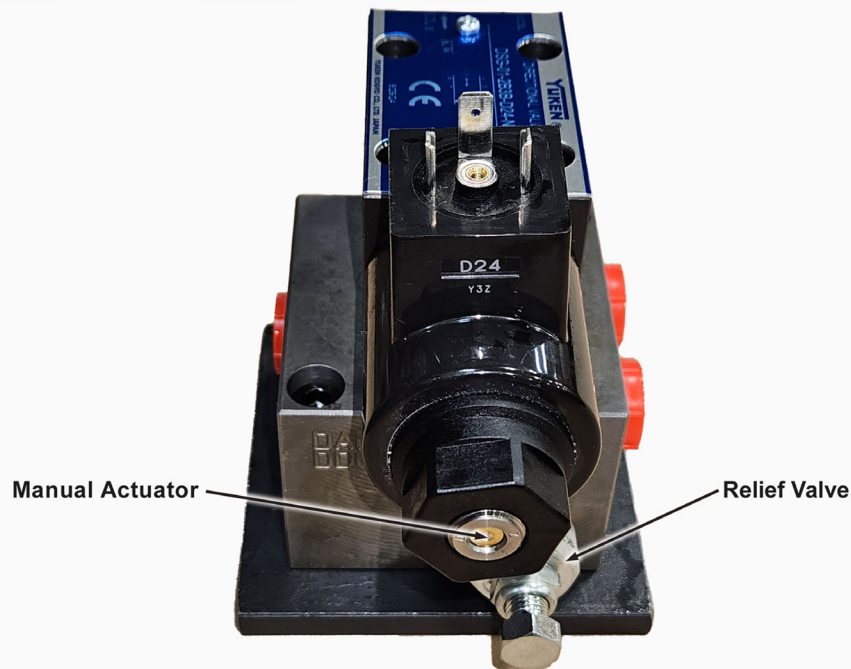
**FIGURE 5: HYDRAULIC VALVE COMPONENT IDENTIFICATION
FRONT VIEW**

Manual Actuator

Relief Valve
