**VIRGINIA DEPARTMENT OF HOUSING AND COMMUNITY DEVELOPMENT**

**2015 Code Change Cycle  
Attachments from cdpVA for Consensus Proposals to go with Book 2**

| <u>Proposal Number</u> | <u>Page No.</u> |
|---|---|
| CTG-310.1 Arc-resistant CSST | 33 |

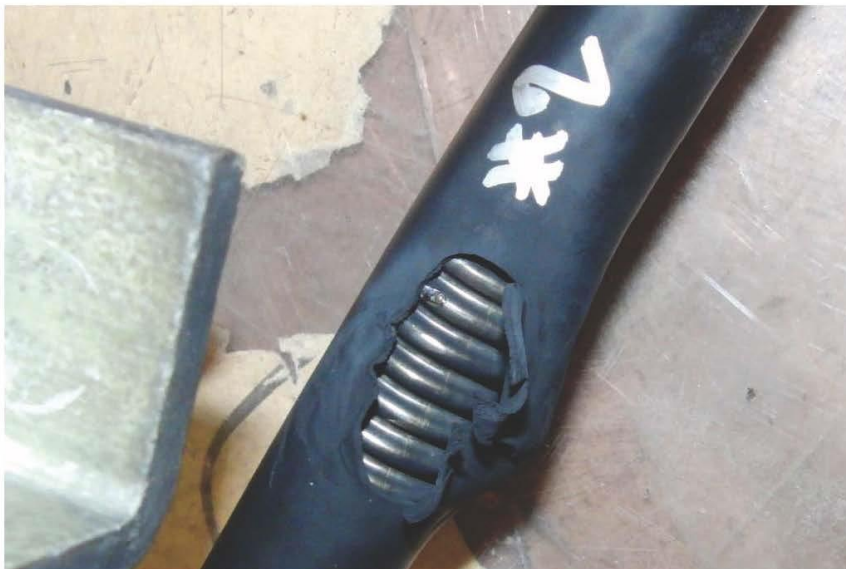
CounterStrike provides its arc-resistance property by dissipating the electrical energy of an arc over a larger surface area of the metal surface through the conductive jacket, significantly reducing metal displacement at the arc location. This process has been verified by laboratory testing with simulated lightning currents of various magnitudes and durations. In these laboratory tests, the dissipation of the electrical current over significant portions of the jacket is clearly evident (Fig. 3). In some cases, the conductive jacket is punctured or ruptured by the arc (Fig. 4) but nevertheless protects the metal tubing from arc damage.

*Fig. 4: High-current arc damage to jacket with undamaged tubing*
